# HOME INSPECTION REPORT

1234 Main Road, Bettys Bay

**OVERSTRAND HOME INSPECTIONS**

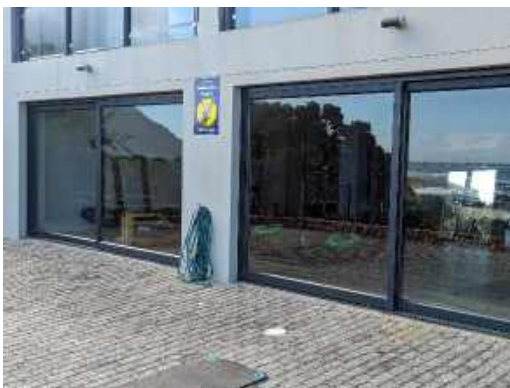
### EXTERIOR - GARAGE CONVERSION ▲

**Description:** The garage has been converted to a gym.

**Location:** Bottom centre of home

**Impact:** Compliance issue

**Recommendation:** Further investigation is made with the seller as to whether the approval from the municipality has been given as the consequences of non-approval will fall to the new owner.

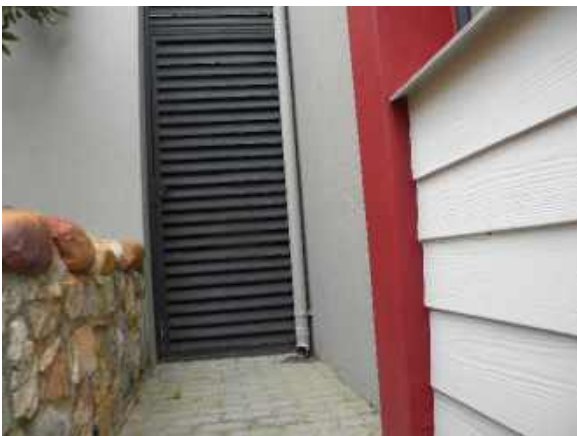
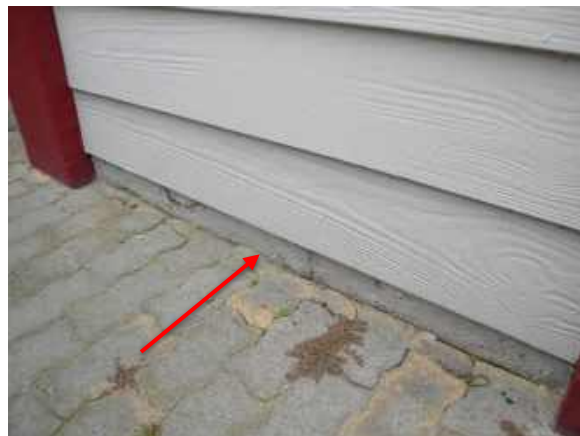
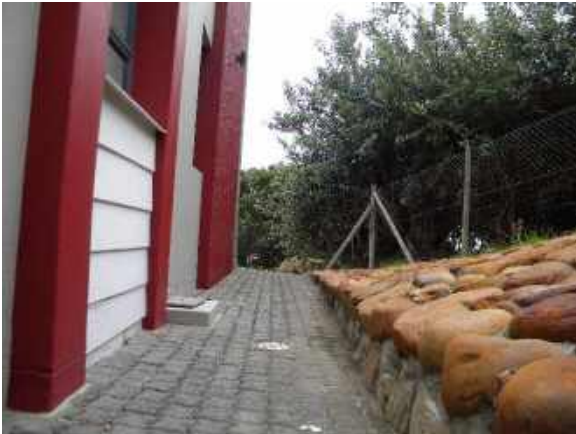
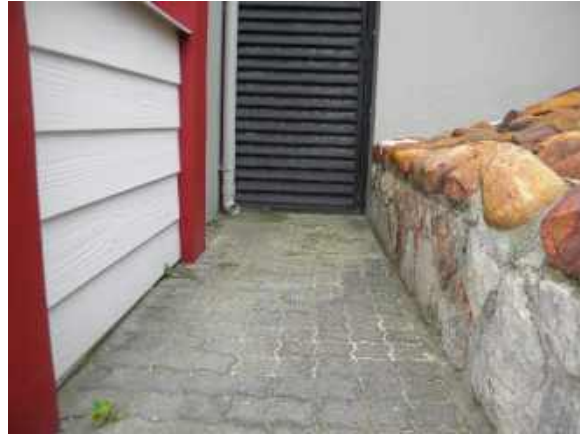
### RETAINING WALLS & GRADING – NEGATIVE GRADING ▲

**Description:** Poor grading and surface drainage

**Location:** Left and right of home

**Impact:** Long-term structural

**Recommendation:** A paving contractor should be engaged to resolve this issue as there are signs of damp on the left-hand side of the home and if left unattended will eventually affect the home's structure.

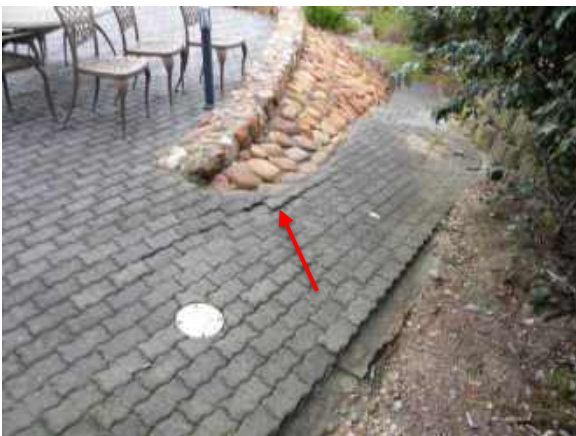
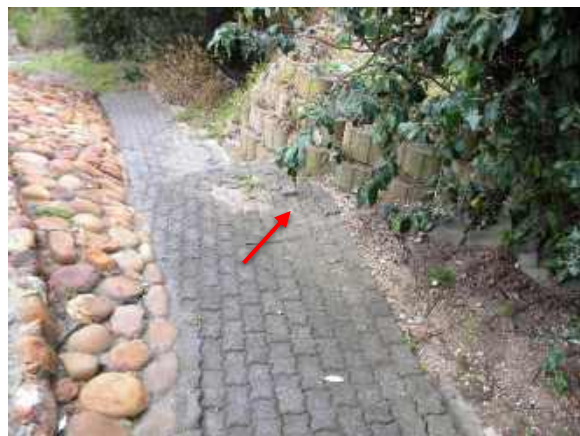
### DRIVEWAYS AND WALKWAYS -SUNKEN PAVERS ▲

**Description:** Sunken and sticking out pavers

**Location:** Bottom left of home

**Impact:** Safety and function

**Recommendation:** DIY fix or handyman to lift pavers add riversand and recompact soil.

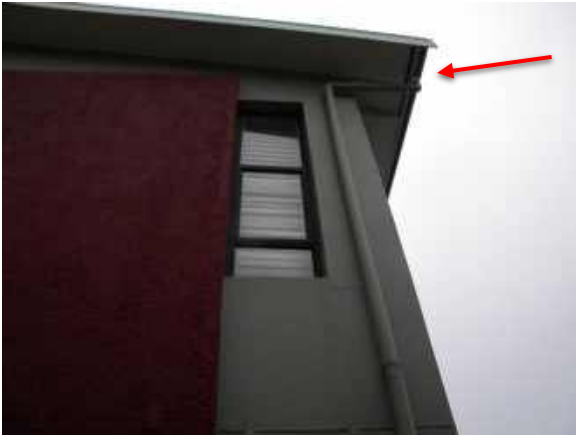
### EAVES, SOFFITS AND FASCIA - LOOSE SOFFIT ▲

**Description:** Soffit loose and some quarter round wooden attachments missing

**Location:** Bottom left of home

**Impact:** Function

**Recommendation:** Recommend engaging a roofer to have the soffit fixed as it currently allows the ingress of insects into the structure.

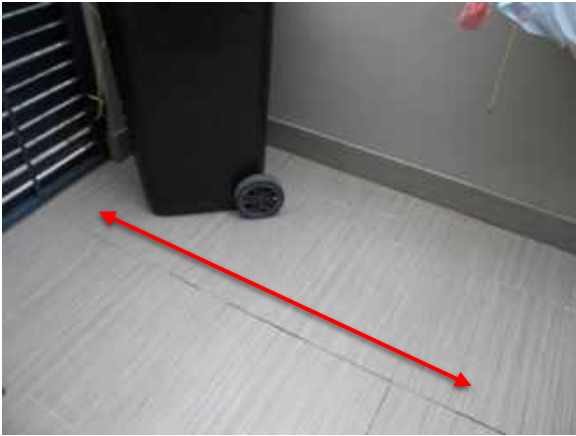
### STOOPS - LOOSE TILES ▲

**Description:** Loose ceramic tiles

**Location:** Top centre of home

**Impact:** Function and cosmetic

**Recommendation:** Tiler to rebond and grout loose tiles

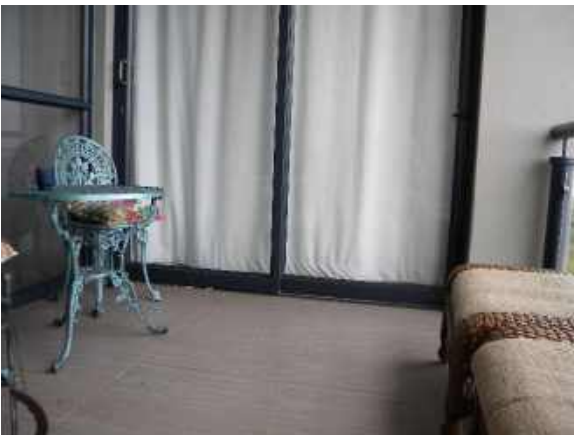
### BALCONY – NO THRESHOLD ▲

**Description:** No threshold at balcony sliding door

**Location:** Bottom right of home

**Impact:** Function and structure

**Recommendation:** The lack of a threshold increases the risk of flooding to the interior. There is a threshold in partial mitigation 2m away, the area is partially sheltered and tiling has positive grading. Further there is no visual evidence of flooding in the interior of the home. I recommend consultation with a building professional with respect to alternatives as the existing structure cannot be remedied without major work being done.

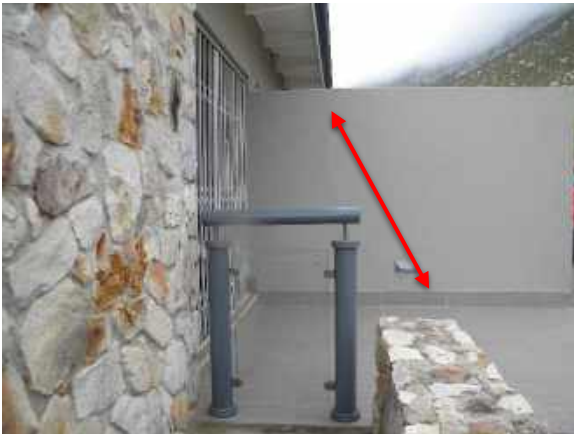
## EXTERIOR WALLS - STRUCTURAL CRACK ▲

**Description:** Repaired structural crack running from top of wall to light fixture

**Location:** Front right

**Impact:** Structural

**Recommendation:** Size of crack cannot be determined due to repair, but it is reopening. The wall moves across the slab and retaining wall and terminates 1.5m thereafter. An articulation joint should fix the problem. Recommend a builder, plumber and electrician as wall, light and piping affected.

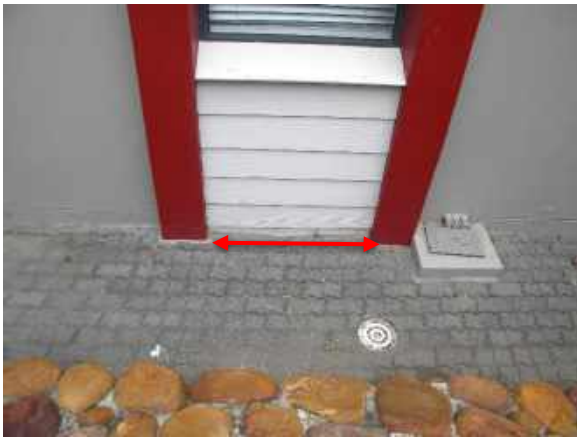
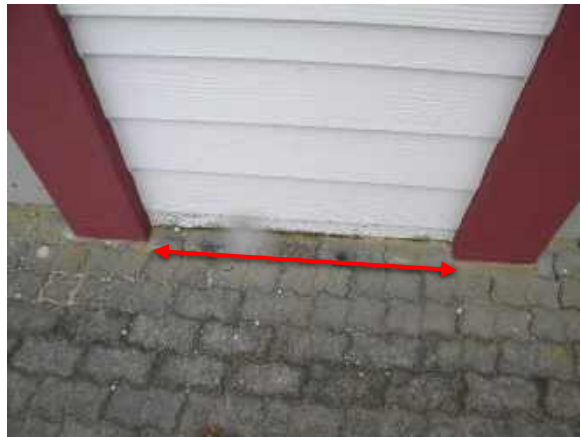
**WALLCOVERING, WATERPROOFING AND TRIM - ROTTING TRIM ▲**

**Description:** Trim in contact with the ground

**Location:** Left and right of the home

**Impact:** Structural

**Recommendation:** DIY or Handyman to cut back the trim from the ground as existing condition will cause water penetration into structural materials.

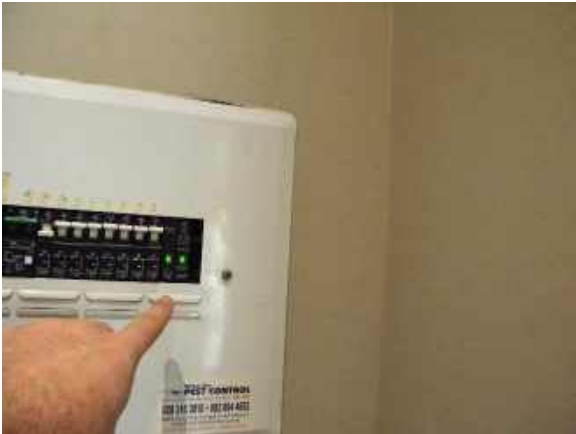
### ELECTRICAL – MISSING BLANK ▲

**Description:** Board is open to the right of the surge protectors

**Location:** Pantry

**Impact:** Compliance and Safety

**Recommendation:** A blank is necessary to prevent someone's finger from slipping below the DB board cover plate and touching exposed wiring underneath. I recommend installation by an electrician

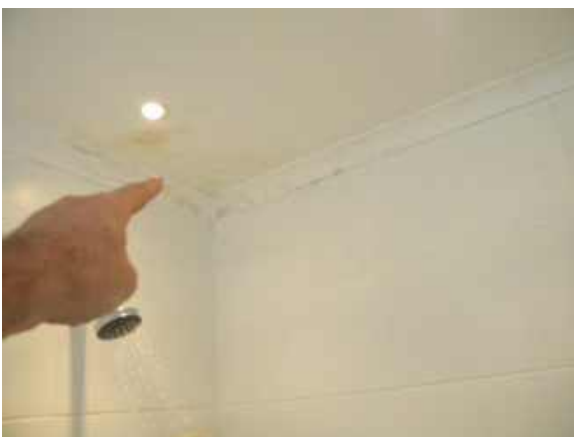
### **BATHROOM – CEILING ACTIVE LEAK ▲**

**Description:** Cement ceiling above shower has active leak

**Location:** Lower-level left of the home

**Impact:** Structure

**Recommendation:** Cause of the leak could be the shower pan upstairs/waste from the shower/piping. Recommend first determining the cause of the leak by a process of elimination. Do not use upper-level shower and see whether the ceiling dries out. If it dries out, rake out grout at the joins to the wall and around waste. Use a high-quality epoxy to reseal. Allow to dry and retest. If it continues then get plumber in to break upper-level pan to test for leak then check plumbing in wall.

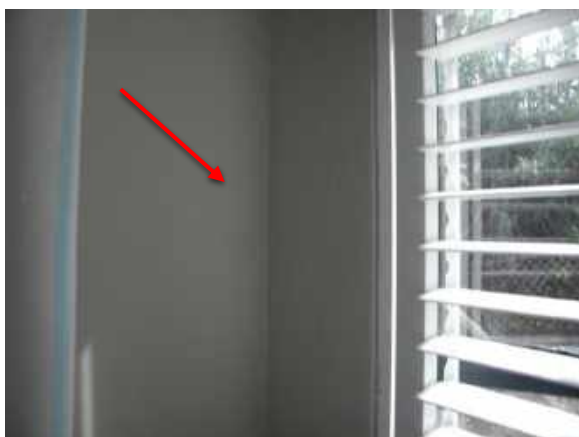
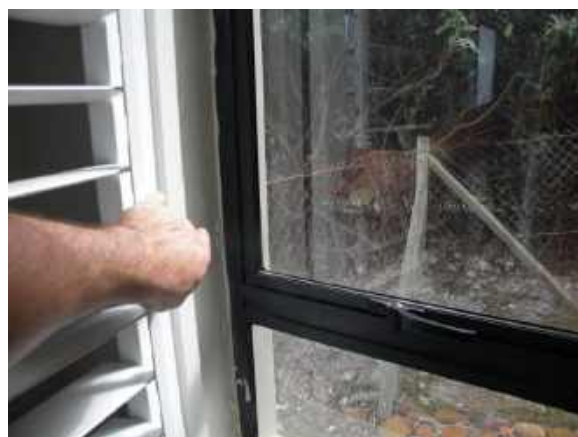
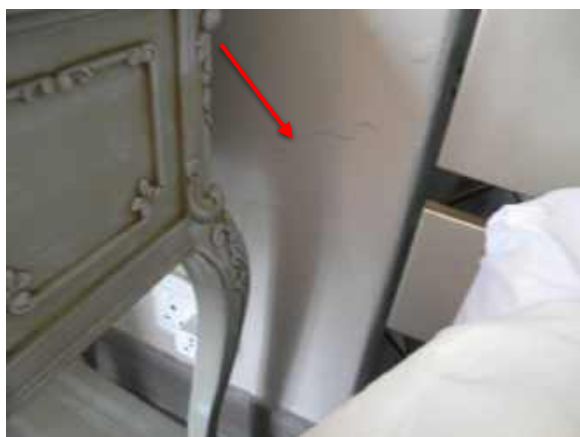
## BATHROOM & BEDROOM WALLS – SIGNS OF DAMP ▲

**Description:** Signs of damp on walls at various locations. Moisture elevated but not an active damp situation

**Location:** Lower-left and Upper left bedrooms and bathrooms on the left wall.

**Impact:** Function

**Recommendation:** The home has cavity walls and is required to have weep-holes on the upper and lower level as well as above windows – I observed that some of the weep-holes were painted over trapping moisture in the walls. I recommend first remedying this situation and waiting for the wall to dry out. If it dries out get a plasterer to re-rhinolite (skim coat) the wall and paint. If it does not, contact a waterproofing specialist.

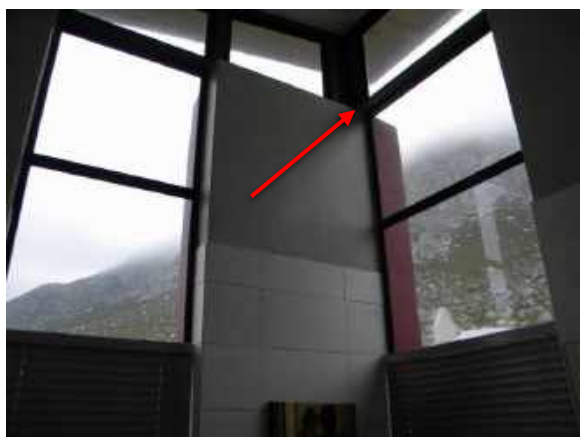
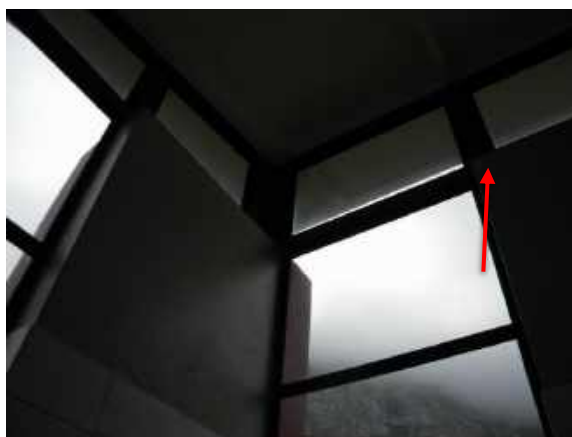
### BATHROOM – WINDOWS SIGNS OF A LEAK ▲

**Description:** Efflorescence seen on window structure near ceiling

**Location:** Upper-level left and right of home

**Impact:** Function

**Recommendation:** Aluminium windows are fitted after a home is built and are caulked to waterproof. The caulking deteriorates through time and needs to be redone by a waterproofing specialist.

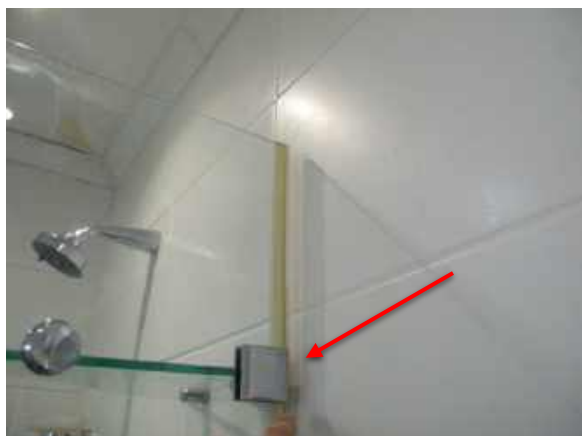
### BATHROOM – SHOWER STRUCTURE DETACHED FROM WALL ▲

**Description:** Bolt fixing safety glass to wall has pulled out. Unable to open or close glass door

**Location:** Lower-level right of home

**Impact:** Function

**Recommendation:** Recommend fix by Glazier

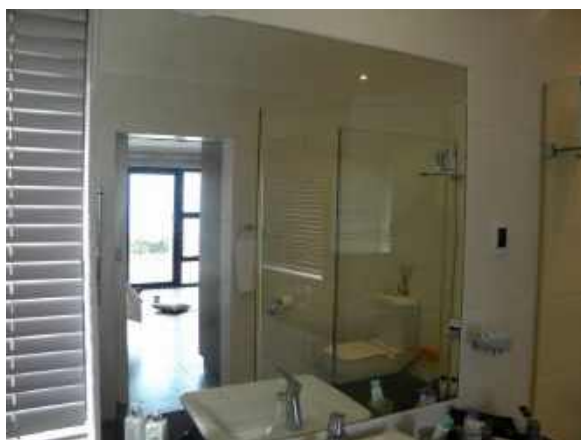
### BATHROOM WALLS – DAMAGED MIRROR ▲

**Description:** Black spots on mirror

**Location:** Lower- level left, upper-level right of home

**Impact:** Cosmetic

**Recommendation:** When the steam or humidity rises to the top of the room and ventilation is not sufficient, the mirror (which is normally positioned high up in the room) is the first thing to steam up. This eventually causes the silver lining behind the mirror to deteriorate. Recommend replacement by glazier.

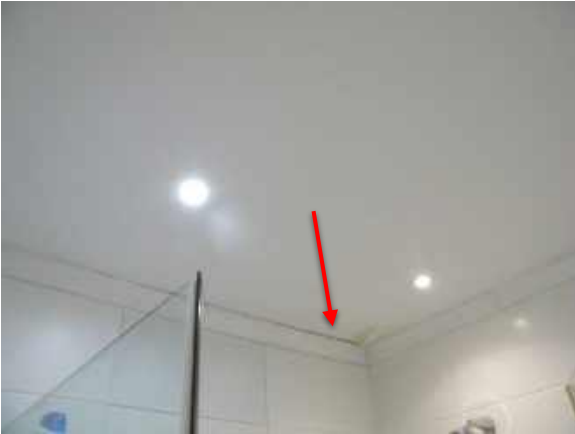
### BATHROOM – CEILING & CORNICE DAMP AND MOLD ▲

**Description:** Damp stains and mold above shower

**Location:** Lower-level right side of house

**Impact:** Cosmetic

**Recommendation:** DIY or Handyman to treat mould with chlorine and repaint.

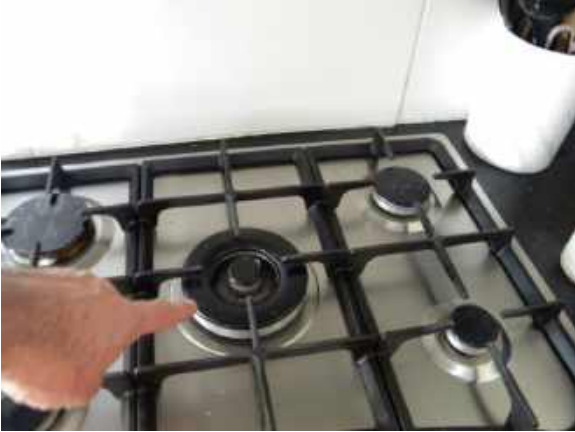
### KITCHEN – NONFUNCTIONING STOVE BURNER ▲

**Description:** Centre burner on stove not igniting

**Location:** Kitchen

**Impact:** Functional

**Recommendation:** Ignitor is working but burner does not light. DIY or handyman to thoroughly clean and check for blockages.

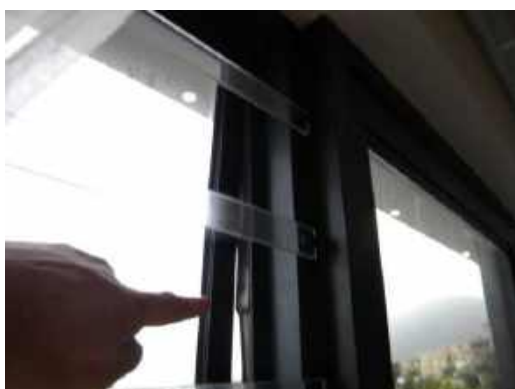
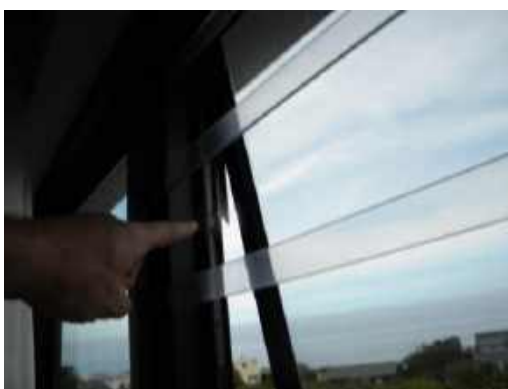
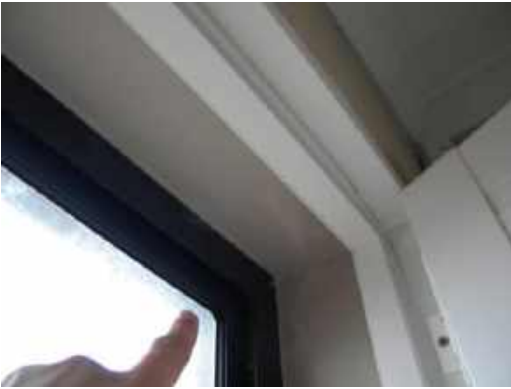
### BEDROOM – WINDOW HINGES BROKEN ▲

**Description:** Three window friction hinges broken

**Location:** Lower-level right bedroom

**Impact:** Function

**Recommendation:** Recommend fix by aluminium window company.
