# HOME INSPECTION REPORT

1234 Main Road, Bettys Bay

**OVERSTRAND HOME INSPECTIONS**

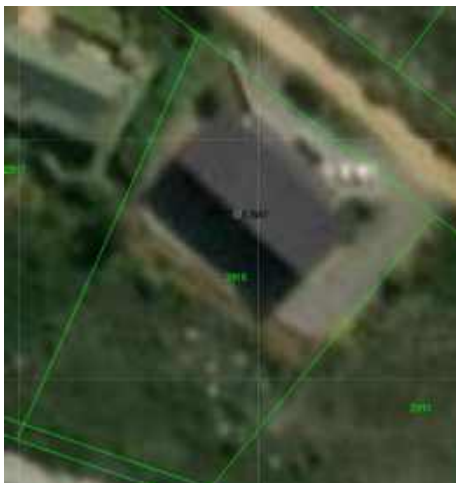
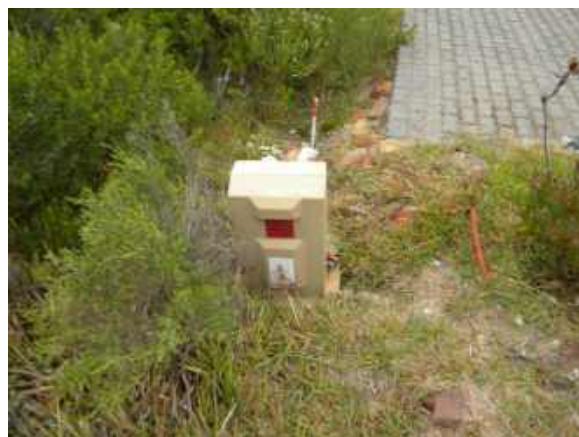
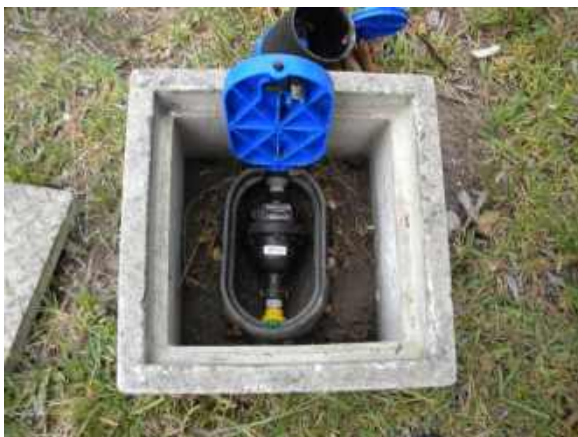
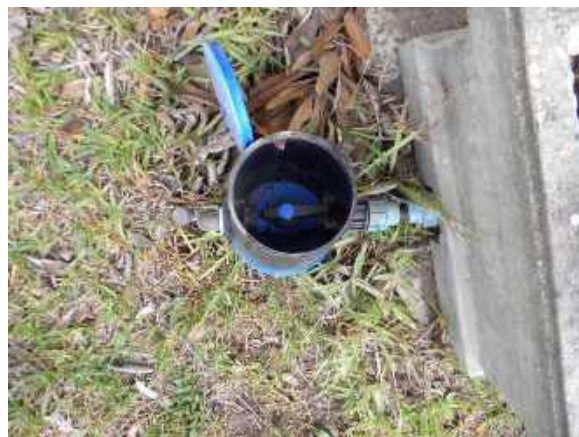
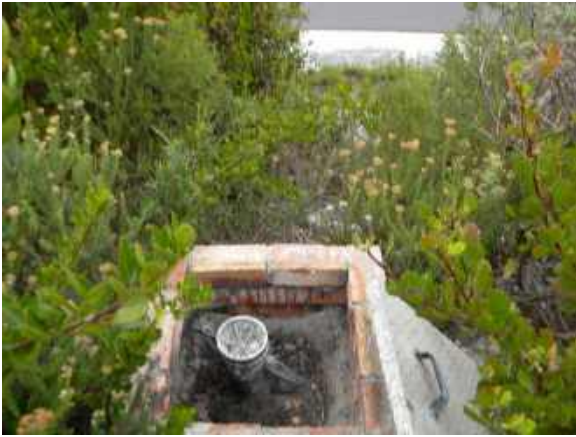
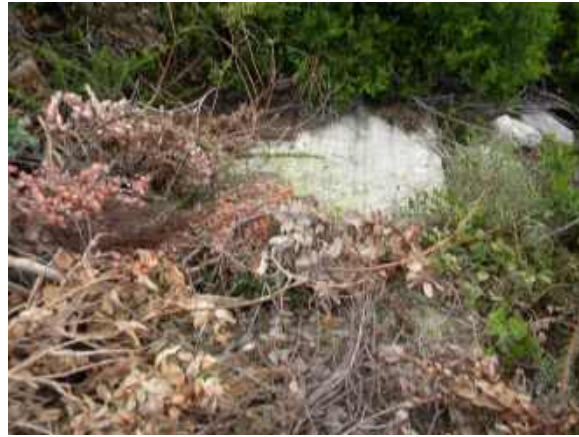
### EXTERIOR - GARAGE CONVERSION ▲

**Description:** The garage has been converted to a gym.

**Recommendation:** Further investigation is made with the seller as to whether the approval from the municipality has been given as the consequences of non-approval will fall to the new owner.

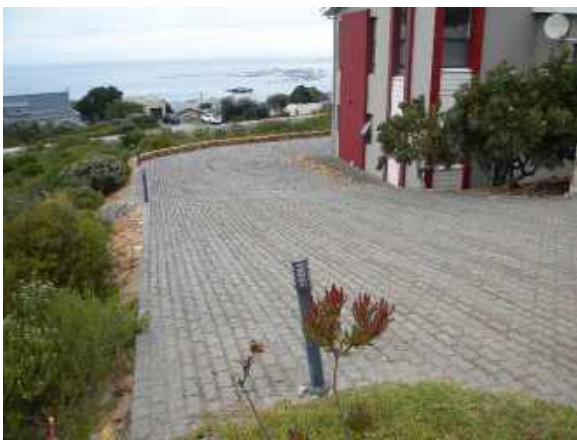
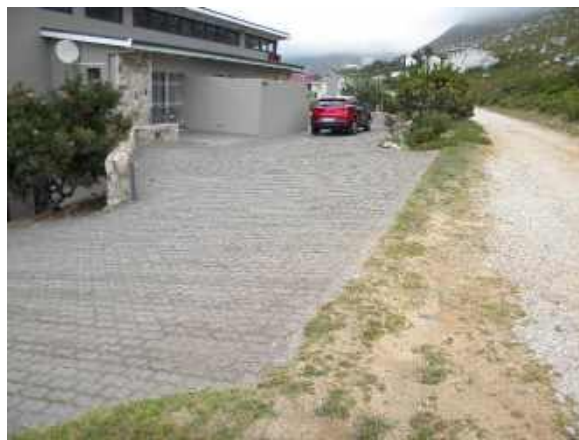
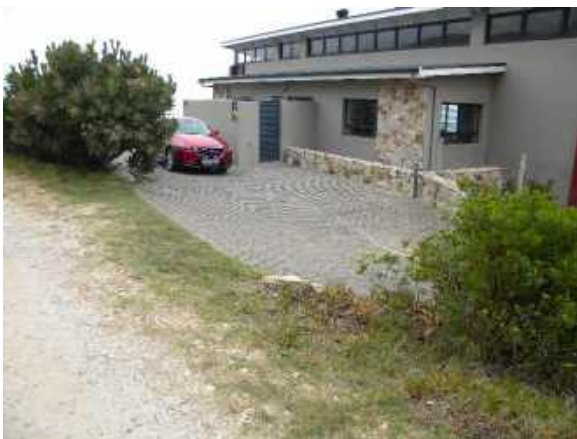
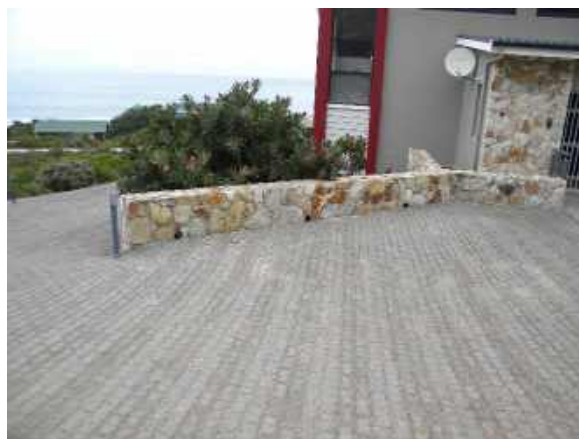
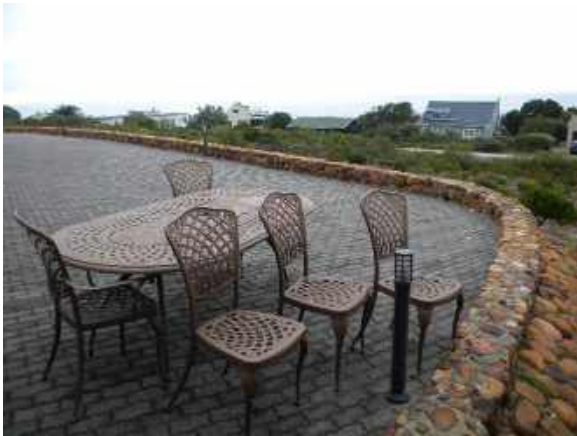
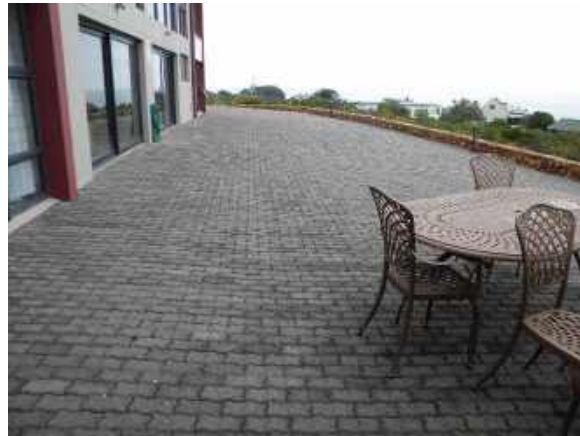
### RETAINING WALLS & GRADING – NEGATIVE GRADING ▲

**Description:** Poor grading and surface drainage

**Recommendation:** A paving contractor should be engaged to resolve this issue as there are signs of damp on the left-hand side of the home and if left unattended will eventually affect the home's structure.

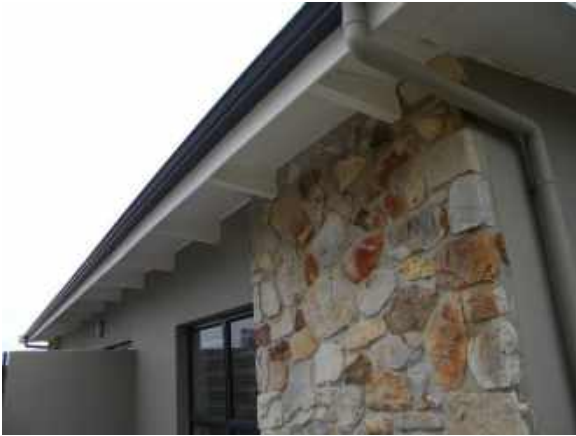
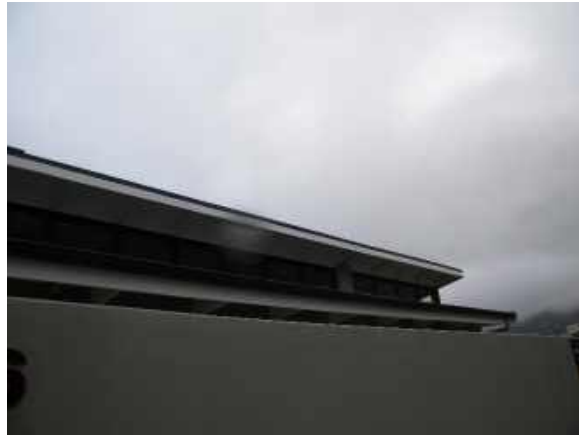
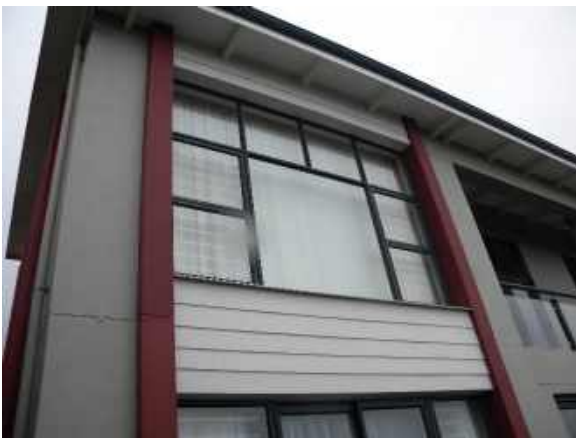
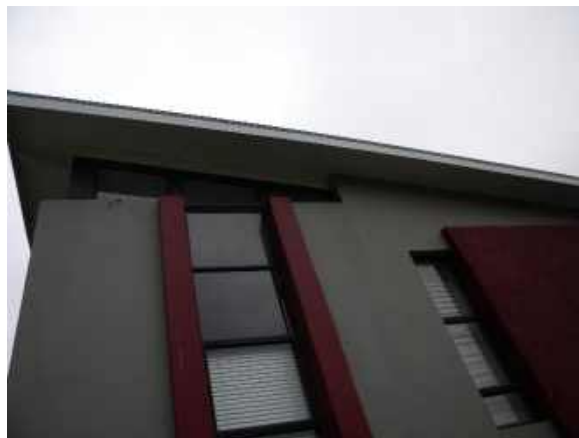
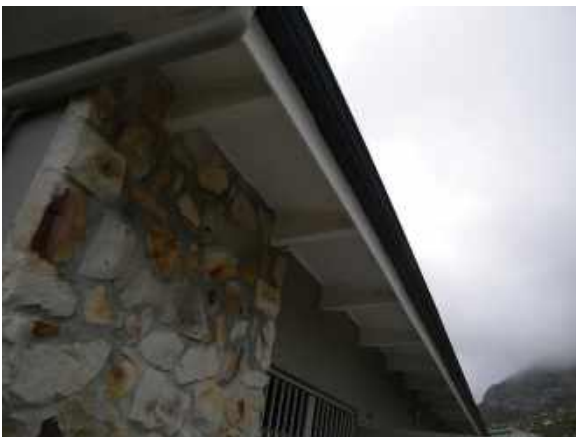
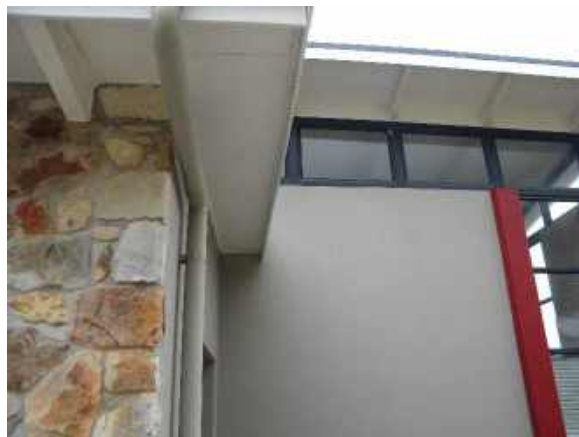
### EAVES, SOFFITS AND FASCIA - LOOSE SOFFIT ▲

**Description:** Soffit loose and some quarter round wooden attachments missing

**Recommendation:** Recommend engaging a roofer to have the soffit fixed as it currently allows the ingress of insects into the structure.

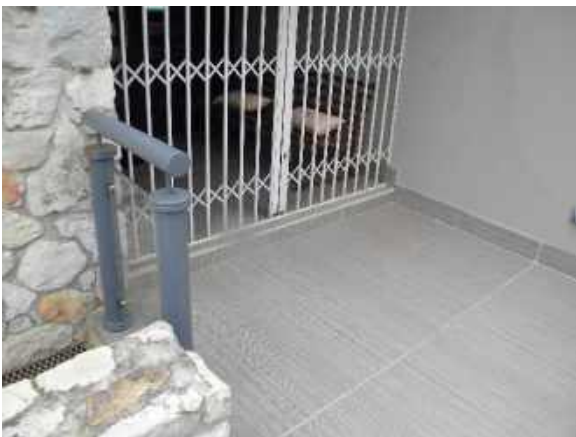
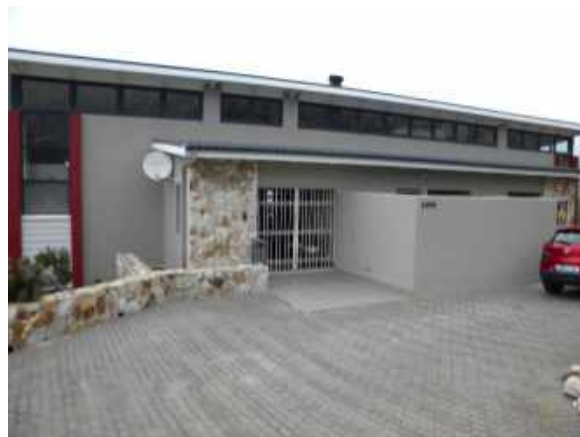
### STOOPS - LOOSE TILES ▲

**Description:** Loose ceramic tiles

**Recommendation:** Tiler to rebond and grout loose tiles

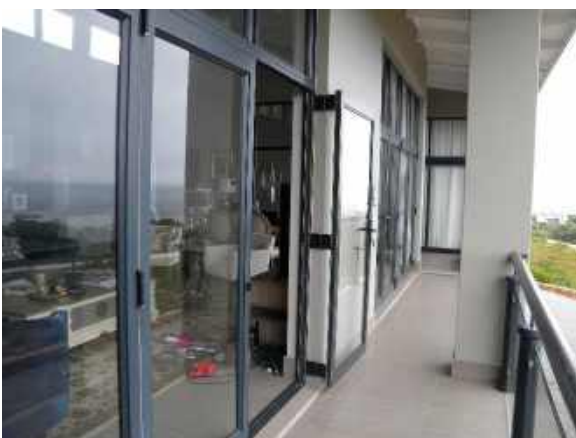
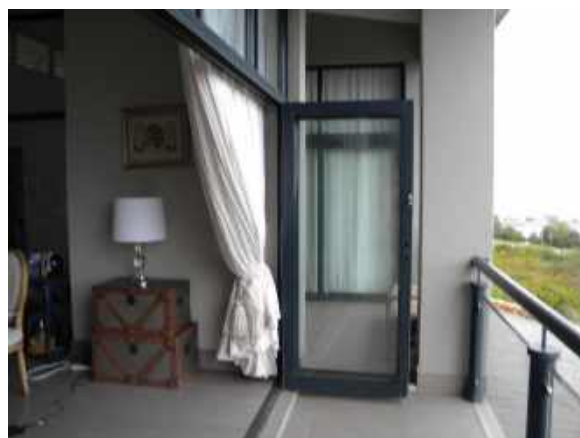
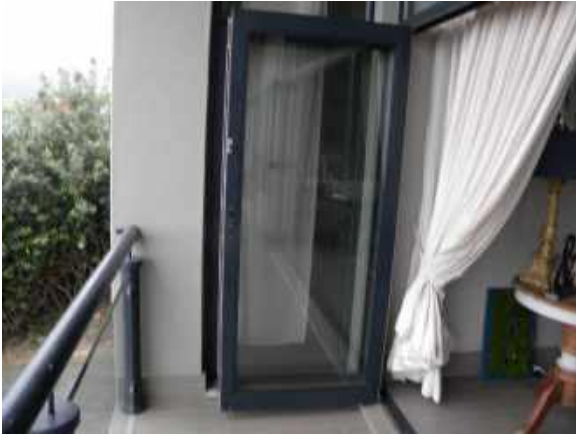
### BALCONY – NO THRESHOLD ▲

**Description:** No threshold at balcony sliding door

**Recommendation:** The lack of a threshold increases the risk of flooding to the interior. There is a threshold in partial mitigation 2m away, the area is partially sheltered and tiling has positive grading. Further there is no visual evidence of flooding in the interior of the home. I recommend consultation with a building professional with respect to alternatives as the existing structure cannot be remedied without major work being done.

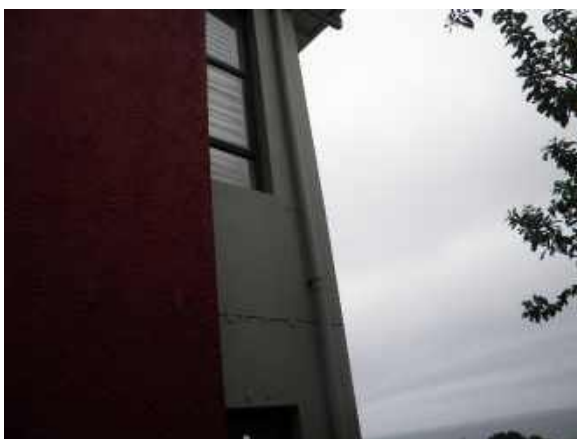
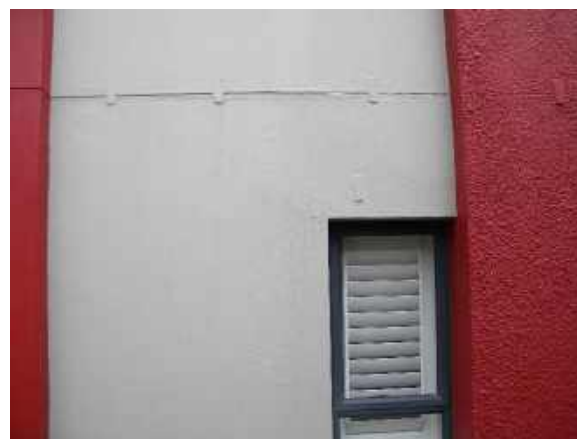
**Comment:** Home needs repainting and filling plaster cracks

## EXTERIOR WALLS - STRUCTURAL CRACK ▲

**Description:** Repaired structural crack running from top of wall to light fixture

**Recommendation:** Size of crack cannot be determined due to repair, but it is reopening. The wall moves across the slab and retaining wall and terminates 1.5m thereafter. An articulation joint should fix the problem. Recommend a builder, plumber and electrician as wall, light and piping affected.

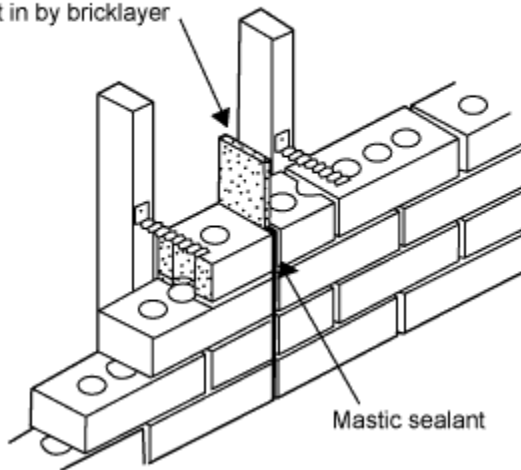
Compressible foam joint  
filler and mastic-backing  
built in by bricklayer

Articulation joints should be located at positions where concentrations or variations in the potential development of stress might occur, such as at changes in wall height; changes in wall thicknesses; and deep chases or rebates for service pipes. An articulation joint is a gap which runs through the wall that is filled with a compressible filler and sealed with a sealant which is capable of withstanding the range of movements which are expected to take place.

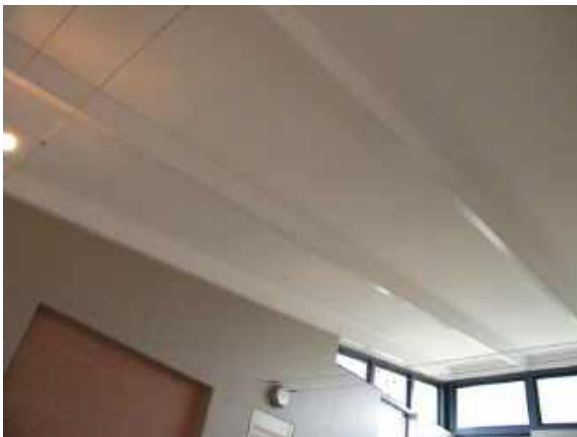
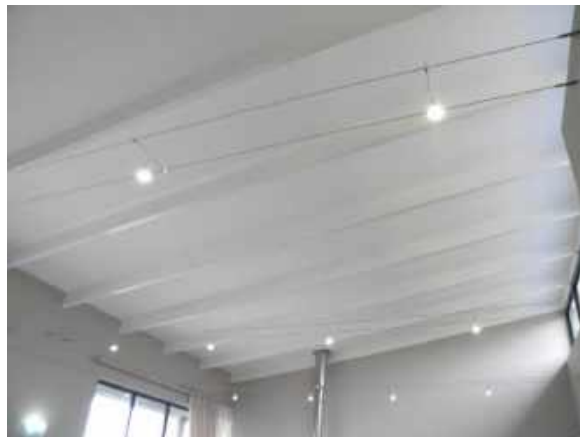
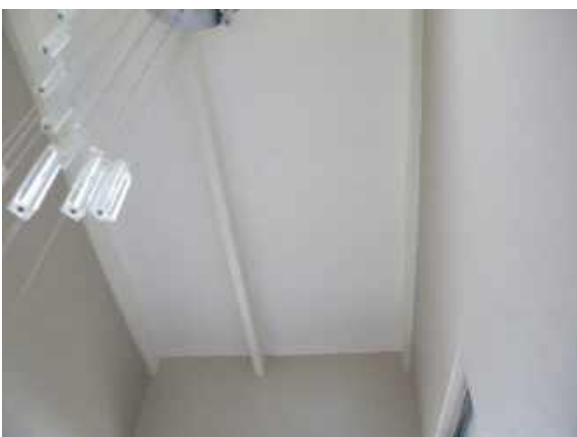
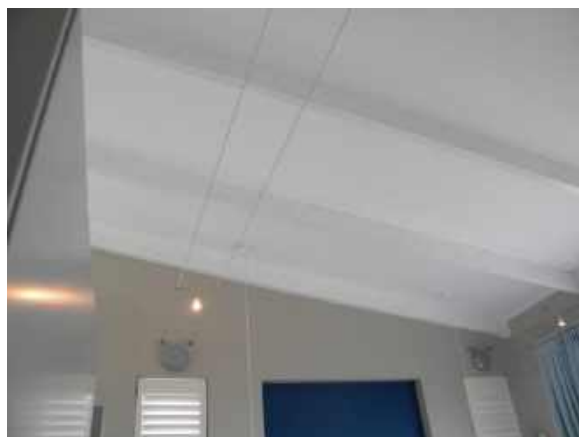
**Comment:** Roof is cathedral in design with exposed beams

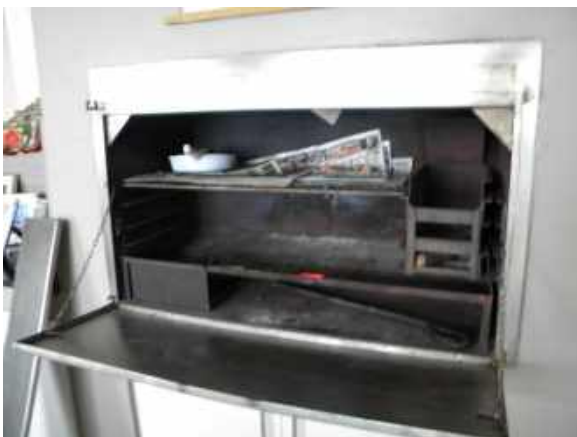
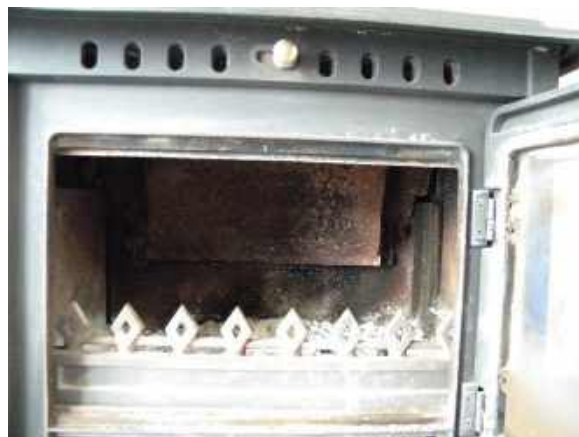
Chimney	√!!	BBQ	√
Flue	√!!	Factory built heater	√
Damper	√	Type of heater / BBQ	steel

**Comment:** All fireplaces/BBQ must be inspected before first use and cleaned once a year.

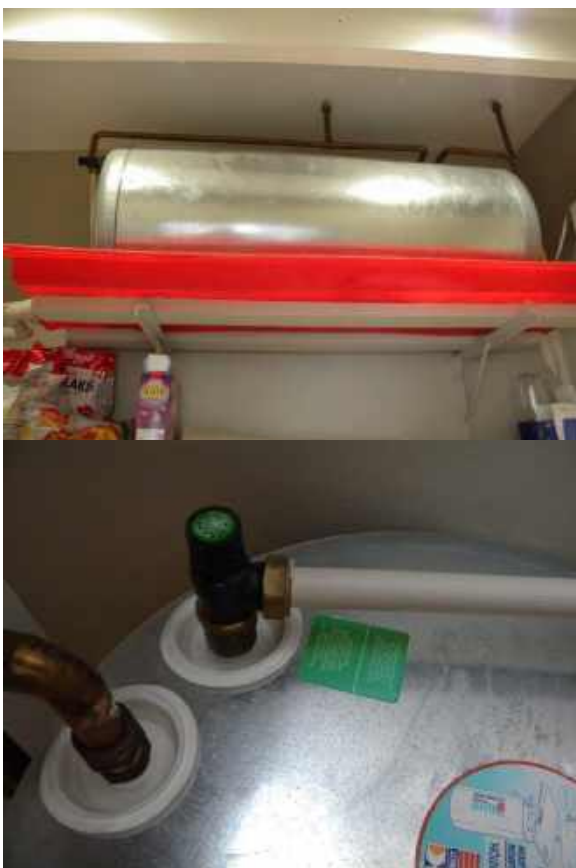
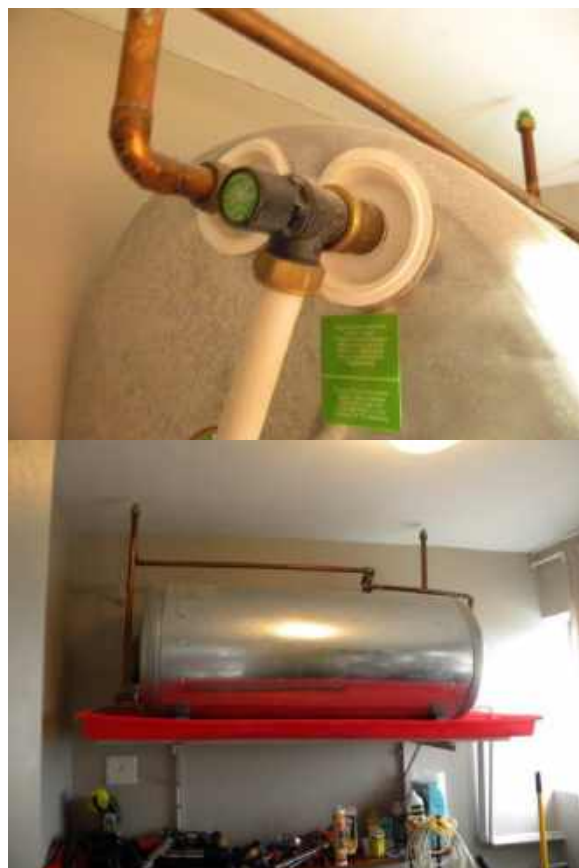
**Comment:** Recommend lagging on hot water and cold-water pipes around geyser.

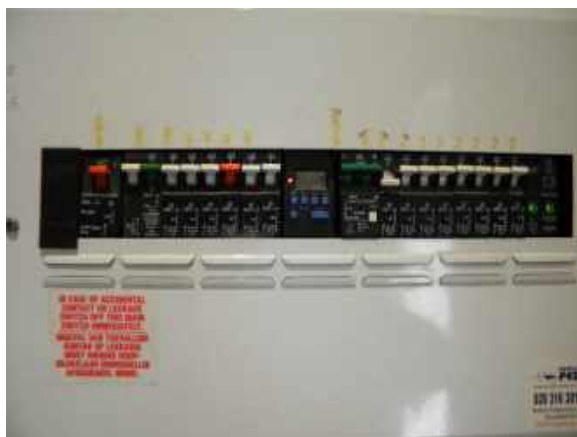
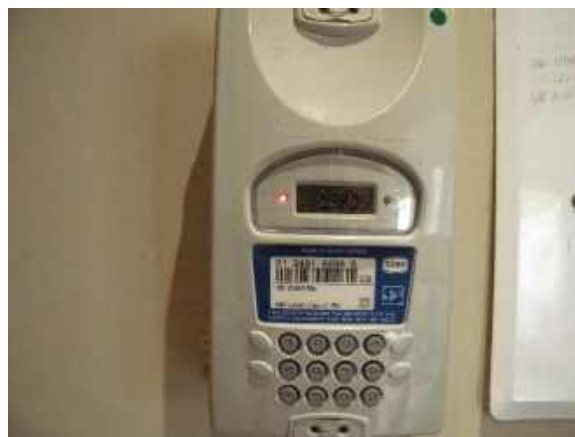
Location	Pantry	Board cover attached & not rusted	✓
Main electric shutoff	✓ 63A	No gaps on the board	▲
Circuit breakers labeled	✓	No breakers down	5A down

c. 5A alarm breaker found in the off position

**Comment:** A type 2 surge protection device has been installed to protect against induced lightning strikes up to 2km away and switch surges from loadshedding.

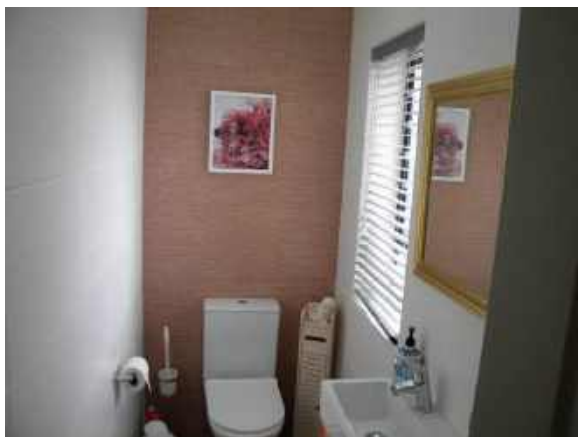
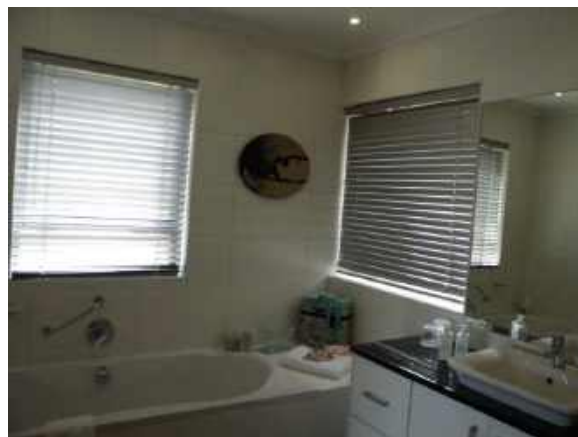
**Comment:** a. \* Functional flow – tested for deficiencies in water supply by running two fixtures simultaneously.

b. Towel rail warmers were tested.

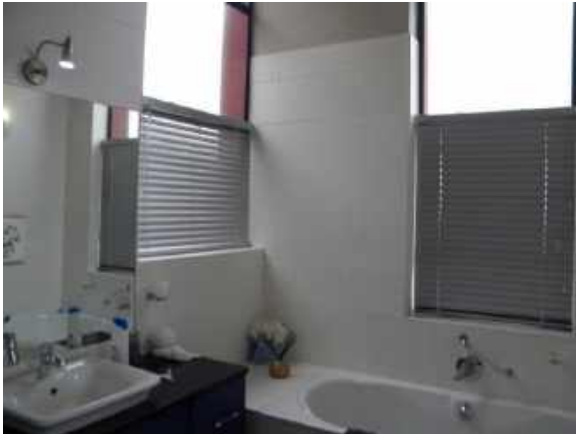
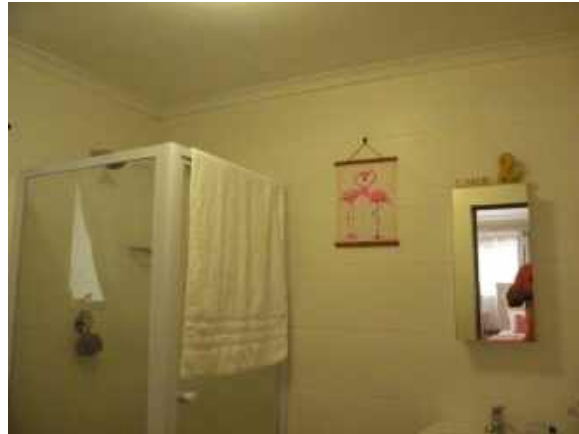
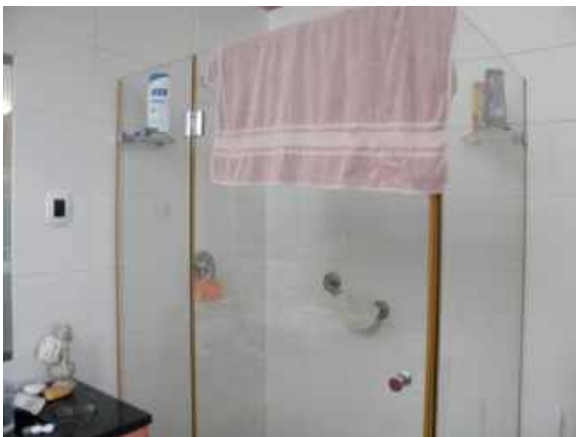
### **BATHROOM – CEILING ACTIVE LEAK ▲**

**Description:** Cement ceiling above shower has active leak

**Recommendation:** Cause of the leak could be the shower pan upstairs/waste from the shower/piping. Recommend first determining the cause of the leak by a process of elimination. Do not use upper-level shower and see whether the ceiling dries out. If it dries out, rake out grout at the joins to the wall and around waste. Use a high-quality epoxy to reseal. Allow to dry and retest. If it continues then get plumber in to break upper-level pan to test for leak then check plumbing in wall.

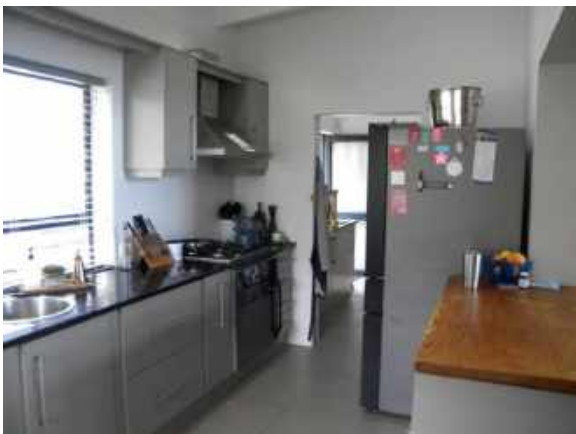
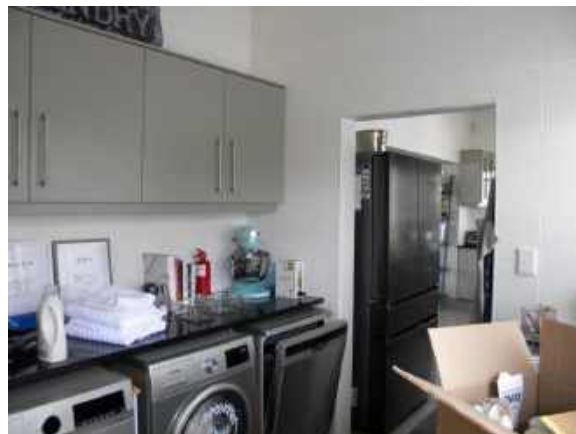
### KITCHEN – INCORRECTLY WIRED RECEPTACLE ▲

**Description:** Two pin and three pin hybrid incorrectly wired

**Recommendation:** I found a live-neutral fault at the two-pin plug in the kitchen. Live neutral reverse is a term used by electricians to indicate that the neutral wire in a socket has been wrongly connected to the terminal intended for the live or hot wire. This is a safety hazard because it means that the socket cannot properly be turned off. Recommend repair by electrician.

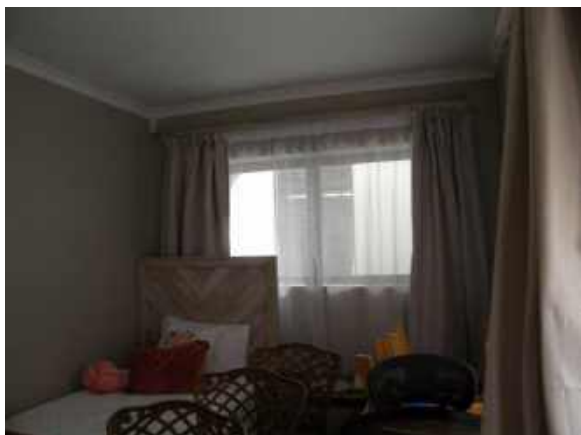
### LIVING ROOM – INCORRECTLY WIRED RECEPTACLE ▲

**Description:** Two pin and three pin hybrid incorrectly wired
